== USS VICKSBURG (CG-69) ==
SEMAT II SHELL CONDITION ASSESSMENT
SURVEY
INTERIOR AREAS
10/22/01 TO 11/02/01

PREPARED BY
SUPERVISOR OF SHIPBUILDING CONVERSION
AND
REPAIR
PORTSMOUTH, VIRGINIA
11/09/01

USS VICKSBURG (CG-69)
SHELL CONDITION ASSESSMENT SURVEY, INTERIOR AREAS.

A SEMAT II UNDERWATER HULL AND SUPPORTING STRUCTURE SURVEY OF INTERIOR AREAS WAS CONDUCTED ON BOARD **USS VICKSBURG (CG-69)** FROM 10/22/01 TO 11/02/01 AT MAYPORT NAVAL STATION, JACKSONVILLE FLORIDA.

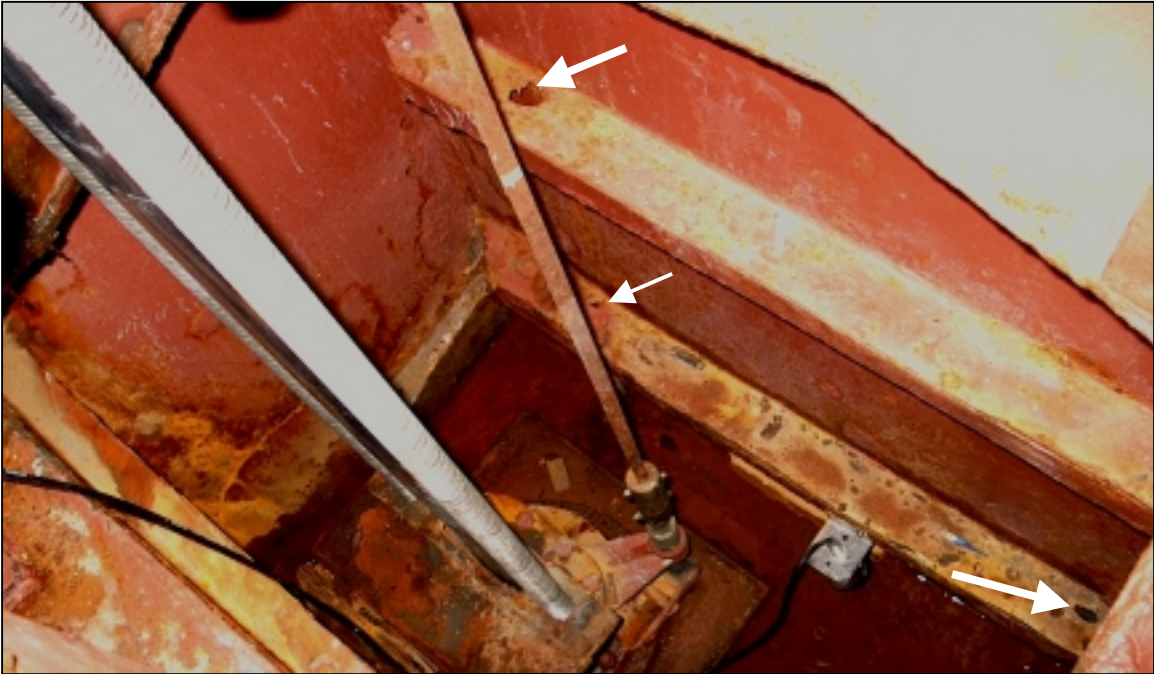
SAFETY HAZARD: 1. SERIOUS - CORRECT AS SOON AS POSSIBLE 2. SERIOUS - SUSPENSION OF EQUIPMENT/SYSTEM/SPACE REQUIRED 3. SERIOUS - WAVIER OF EQUIPMENT/SYSTEM 4. SAFETY ITEM - MINOR 5. COMBUSTIBLE MATERIAL			1. MAINTENANCE ACTION COMPLETED: PARTS DRAWN FROM SUPPLY 2. MAINTENANCE ACTION COMPLETED: REQUIRED PARTS NOT DRAWN FROM SUPPLY 3. MAINTENANCE ACTION COMPLETED: NO PARTS REQUIRED 4. CANCELLED - DEFERRAL WILL BE REMOVED FROM CSMP 5. MAINTENANCE ACTION COMPLETED: 3-M CAPABILITY UTILIZED 6. NONE OF THE ABOVE, DESCRIBE IN REMARKS/DESCRIPTION SECTION			1. MANDATORY 2. ESSENTIAL 3. HIGHLY DESIRABLE 4. DESIRABLE	
DISCREPANCY DESCRIPTION: PER SEMAT II UNDERWATER HULL ASSESSMENT: (5-138-0-E) SEWAGE PLANT NO.1							
PITSWORD AREA IS CORRODED, STIFFNERS ON F/O TANK (6-138-1-F) ARE HOLED (2 X 4 T-BEAM) APPROX 20 SF OF							
CORROSION AND PAINT SEPARATION							
RECOMMENDED REPAIRS: RECOMMEND REPAIR ACTIVITY, CLEAN AND GAS FREE TANK, CUT OUT AND REPLACE APPROX 8 LF OF

PITSWORD AREA, ARROWS INDICATE HOLES IN STIFFNERS INBOARD SIDE OF
F/O TANK (6-138-1-F)

(2 X 4 T-BEAM) LEAK TEST TANK, CLEAN ENTIRE PITSWORD AREA TO BARE METAL PRESERVE AND PAINT TO MATCH							
.							
SSPORT C221 POC: B. WILLIAMS (757) 396-4001 EXT 2130, TPOC: M. MELVIN							
CSMP SUMMARY: PITSWORD AREA STIFFNERS ARE CORRODED.					TEST# MRC 1102/1		
ROOT CAUSE/AMPLIFICATION: H1					STEP# 1,2,3,4 & 5		
SYSTEM LEVEL IMPACT:							
PART NO.	NOMEMCLATURE			QTY	NSN		COST
1							
2							
3							
4							
5							
6							
FIRST CONTACT BREKKE		RATE HT1	SECOND CONTACT CARL		RATE HT2	PHONE	
ASSESSOR / ACT / TECH ID# J. LaROCK/ T. ILGENFRITZ				TD	TL	LOGISTICIAN	TSP
QED SYSTEMS INC.

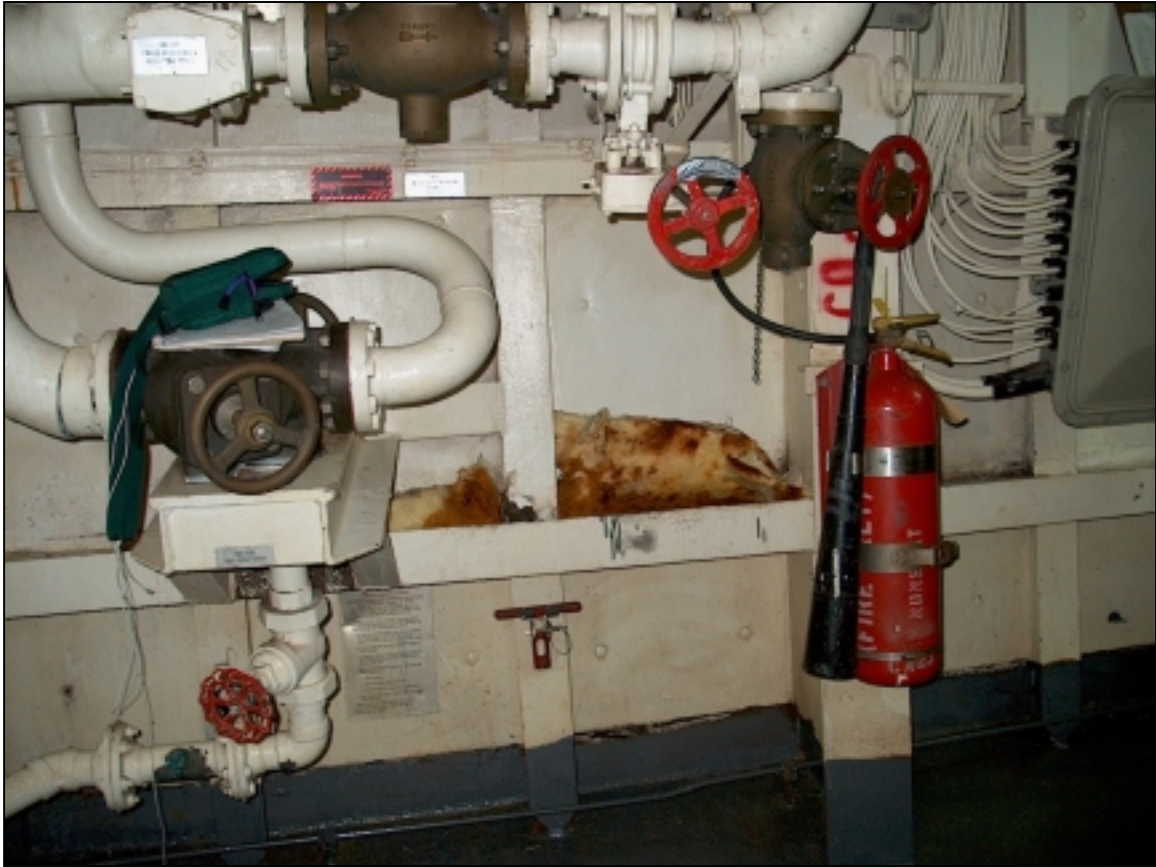
DISCREPANCY DESCRIPTION: PER SEMAT II UNDERWATER HULL ASSESSMENT: PORT AND STBD SIDES (4-58-0-Q) DOME EQUIP RM					
BHD (58 - 78) FROM DECK TO 2 ND STRINGER APPROX 160 SF OF SATURATED LAGGING, MINOR CORROSION AND PAINT SEPARATION.					
RECOMMENDED REPAIRS: RECOMMEND SHIPS FORCE REMOVE APPROX 160 SF OF 2" HULL BOARD. CLEAN AREAS EXPOSED BY REMOVAL PRESERVE AND PAINT, REPLACE LAGGING.					
SSPORT C221 POC: B. WILLIAMS (757) 396-4001 EXT 2186, TPOC: M. MELVIN					
CSMP SUMMARY: SATURATED LAGGING LIGHT CORROSION				TEST# MRC 1102/1	
ROOT CAUSE/AMPLIFICATION: H1				STEP# 1,2,3,4 & 5	
SYSTEM LEVEL IMPACT:					
PART NO.	NOMENCLATURE		QTY	NSN	COST
1					
2					
3					
4					
5					
6					
FIRST CONTACT BREKKE	RATE HT1	SECOND CONTACT CARL		RATE HT2	PHONE
ASSESSOR / ACT / TECH ID# J. LaROCK/ T. ILGENFRITZ QED SYSTEMS INC.			TD	TL	LOGISTICIAN
					TSP

STBD SIDE, APPROXIMATELY 8 FT AFT OF BHD 58, SATURATED LAGGING FROM DECK TO 2ND STRINGER.

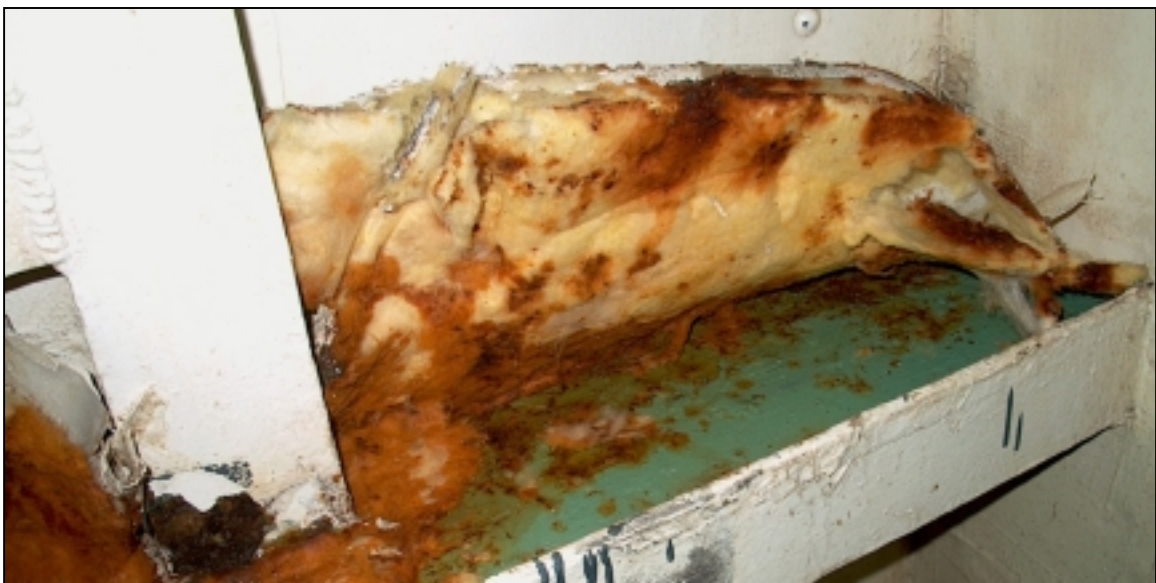
FIRST STRINGER OFF DECK STBD SIDE, APPROX 8 FT AFT OF BHD 58

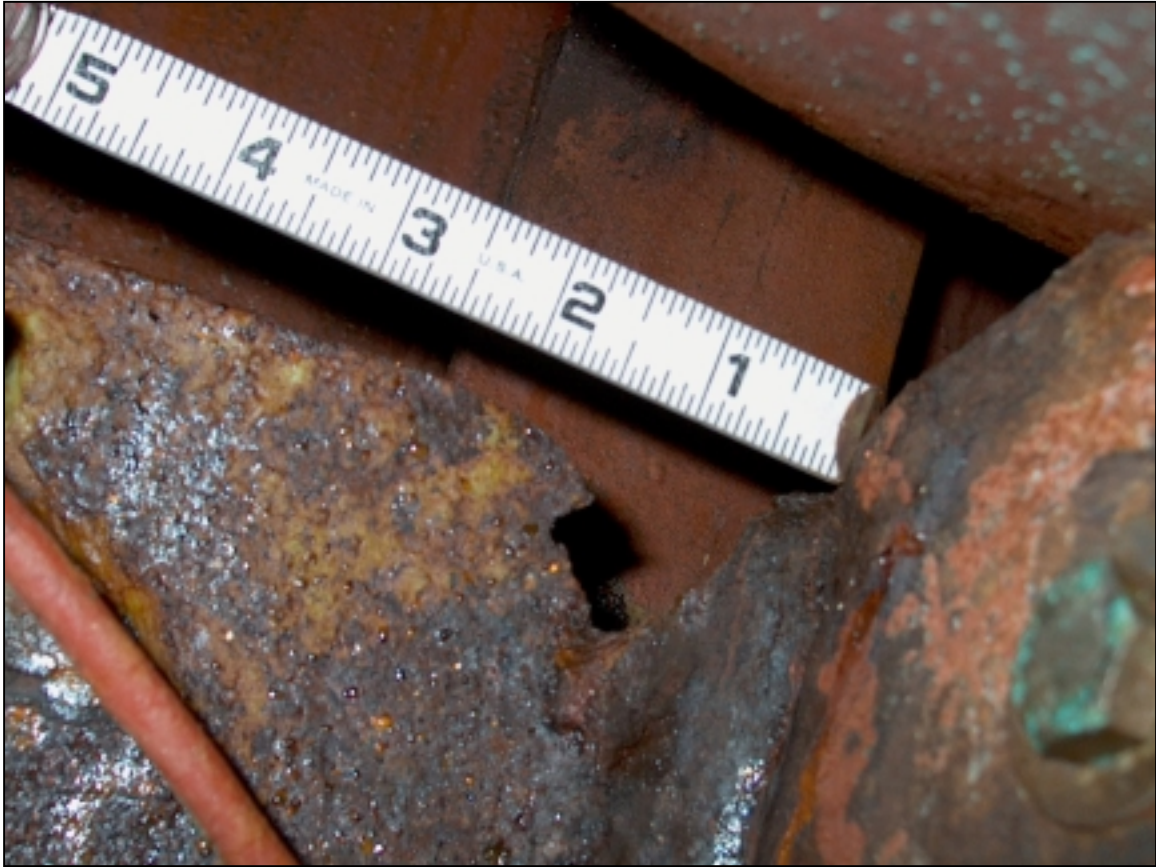
(434) ENTIRE BILGE POCKET HAS SURFACE RUST AND PAINT SEPARATION. APPROXIMATELY 200 SF.							
RECOMMENDED REPAIRS: RECOMMEND REPAIR ACTIVITY CUT OUT APPROX.4FT OF STRINGER FLANGE AND REPLACE WITH							
4X.250 MILD STEEL FLAT BAR.CLEAN PRIME AND PAINT ENTIRE BILGE POCKET. APPROXIMATELY 200 SF							
.							
SSPORT C221 POC: B. WILLIAMS (757) 396-4001 EXT 2130, TPOC: M. MELVIN							
CSMP SUMMARY: FIRST STRINGER IS CORRODED, ENTIRE BILGE POCKET HAS SURFACE RUST AND PAINT SEP.						TEST# MRC 1102/1	
ROOT CAUSE/AMPLIFICATION: H1						STEP# 1,2,3,4 & 5	
SYSTEM LEVEL IMPACT:							
PART NO.	NOMEMCLATURE			QTY	NSN		COST
1							
2							
3							
4							
5							
6							
FIRST CONTACT BREKKE		RATE HT1	SECOND CONTACT CARL		RATE HT2	PHONE	
ASSESSOR / ACT / TECH ID# J. LaROCK/ T. ILGENFRITZ				QED SYSTEMS INC.	TD	TL	LOGISTICIAN
							TSP

CORRODED STRINGER FLANGE APPROXIMATELY 3 FT FWD OF WEB FRAME (434)

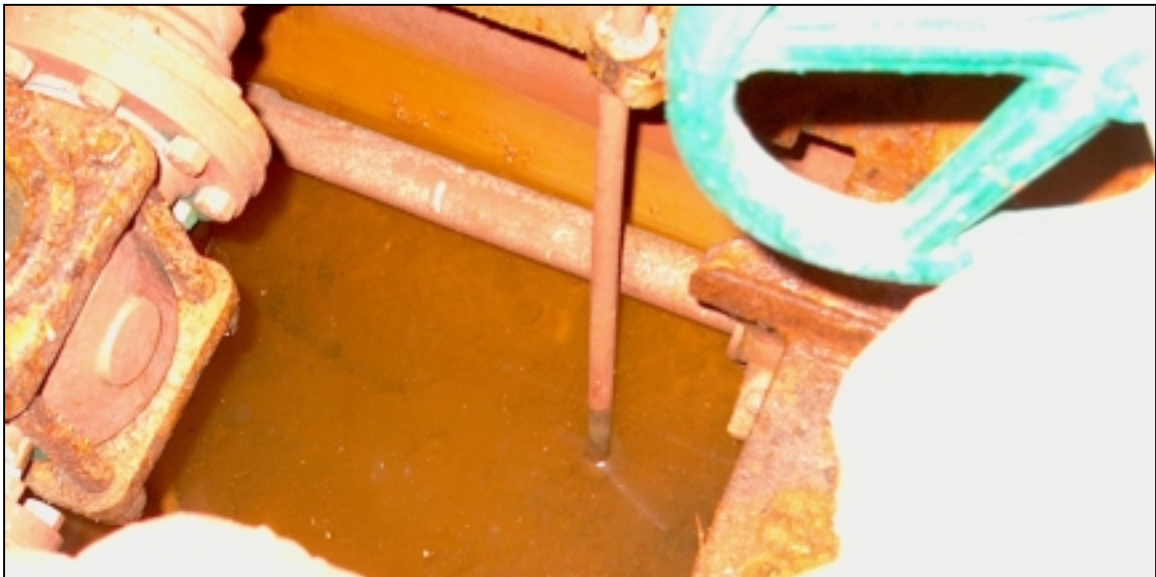
TYPICAL VIEW OF BILGE POCKET, ENTIRE AREA RECOMMENDED FOR
PRESERVATION AND PAINT.

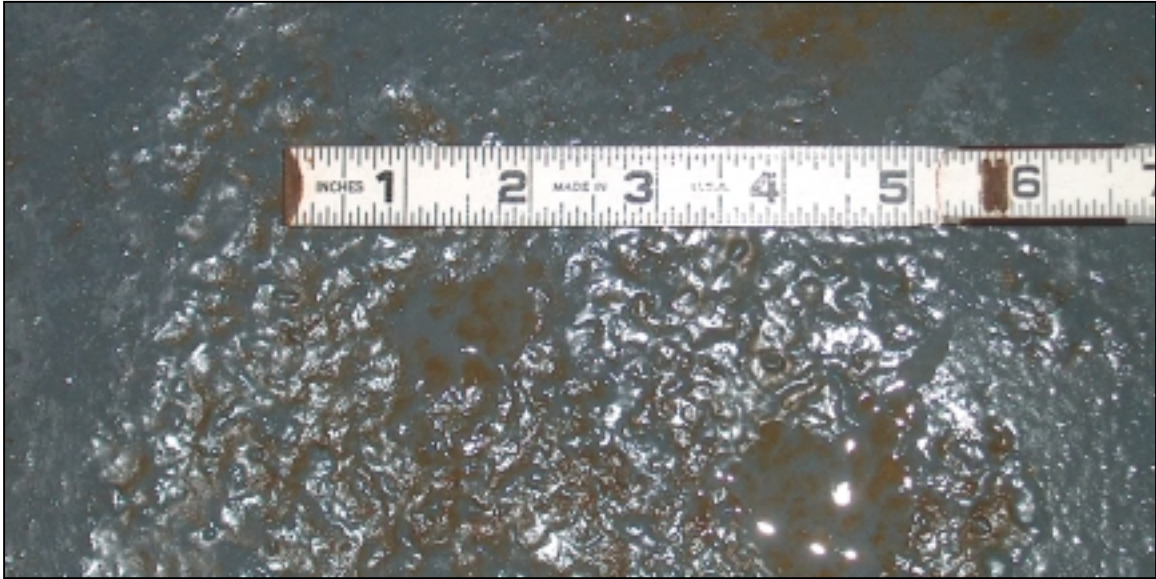
HEAVY PITTING OF TANK TOP/ DECK AFT OF EXPANSION TANK NO. 3
SEE DRAWING FOR U/T READINGS

RECOMMENDED REPAIRS: R ECOMMEND REPAIR ACTIVITY CLEAN AND GAS FREE TANK ,CUT OUT AND REPLACE APPROXX.								
200 SF OF TANK TOP. USE .313 MILD STEEL,PRIME AND PAINT TO MATCH.								
.								
SSPORT C221 POC: B. WILLIAMS (757) 396-4001 EXT 2130, TPOC: M. MELVIN								
CSMP SUMMARY: TANK TOP/DECK HAS HEAVY PITTING AND LOW U/T READINGS						TEST# MRC 1102/1		
ROOT CAUSE/AMPLIFICATION: H1						STEP# 1,2,3,4 & 5		
SYSTEM LEVEL IMPACT:								
PART NO.	NOMEMCLATURE			QTY	NSN		COST	
1								
2								
3								
4								
5								
6								
FIRST CONTACT BREKKE		RATE HT1	SECOND CONTACT CARL		RATE HT2	PHONE		
ASSESSOR / ACT / TECH ID# J. LaROCK/ T. ILGENFRITZ				TD	TL	LOGISTICIAN	TSP	
QED SYSTEMS INC.

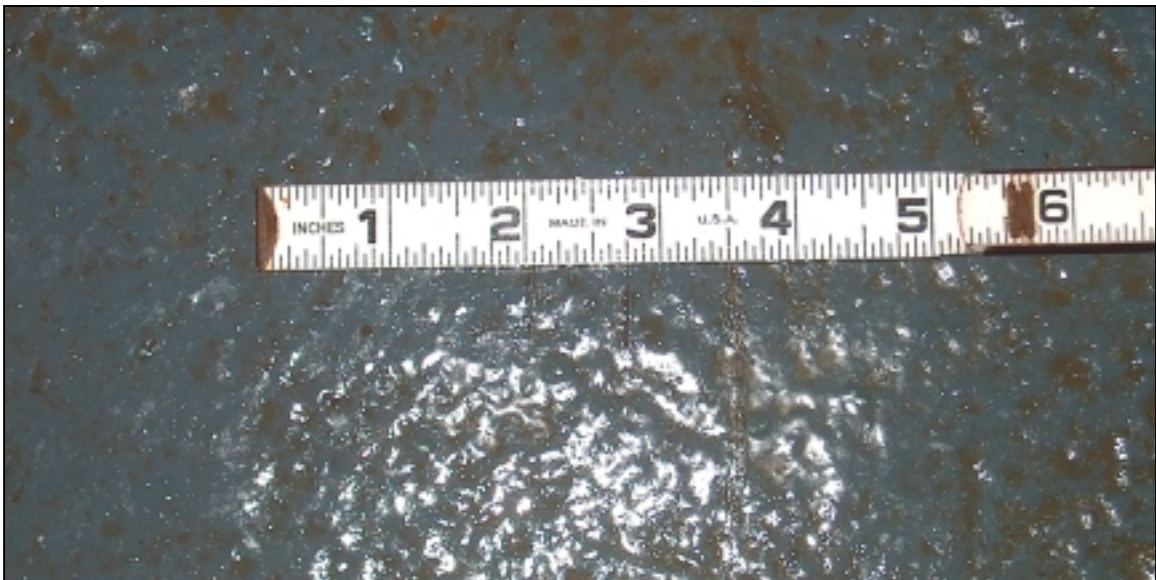
HEAVY PITTING OF TANK TOP / DECK INBOARD OF A/C PLANT RECEIVER R-114

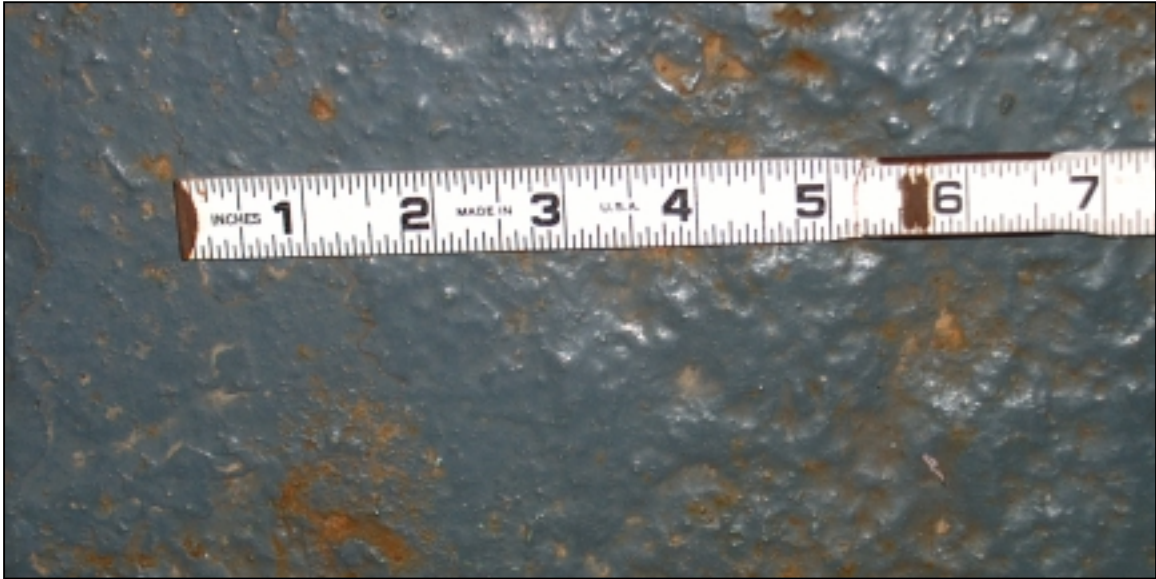
TANK TOP / DECK BETWEEN A/C PLANTS 3 & 4 HAS HEAVY PITTING
SEE DRAWING FOR U/T READINGS

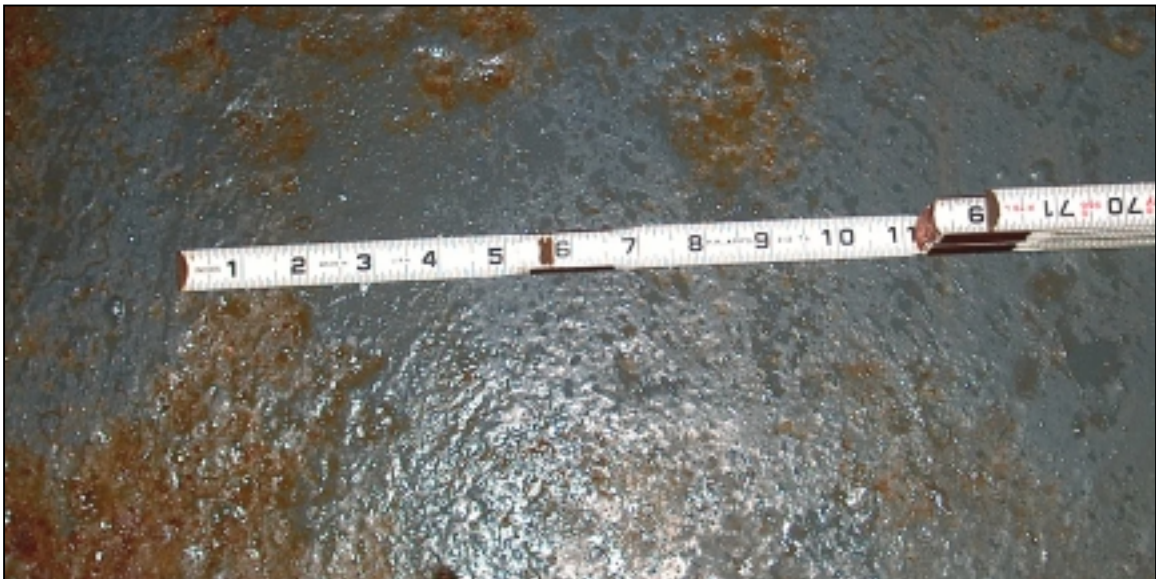
TANK TOP / DECK BETWEEN BHD 398 AND A/C PLANT NO. 4
